FINAL REPORT *OF* A BOARD OF INVESTIGATION

*To Inquire Into*  
THE DESIGN  
AND METHODS OF CONSTRUCTION  
OF WELDED STEEL MERCHANT  
VESSELS

15 JULY 1946

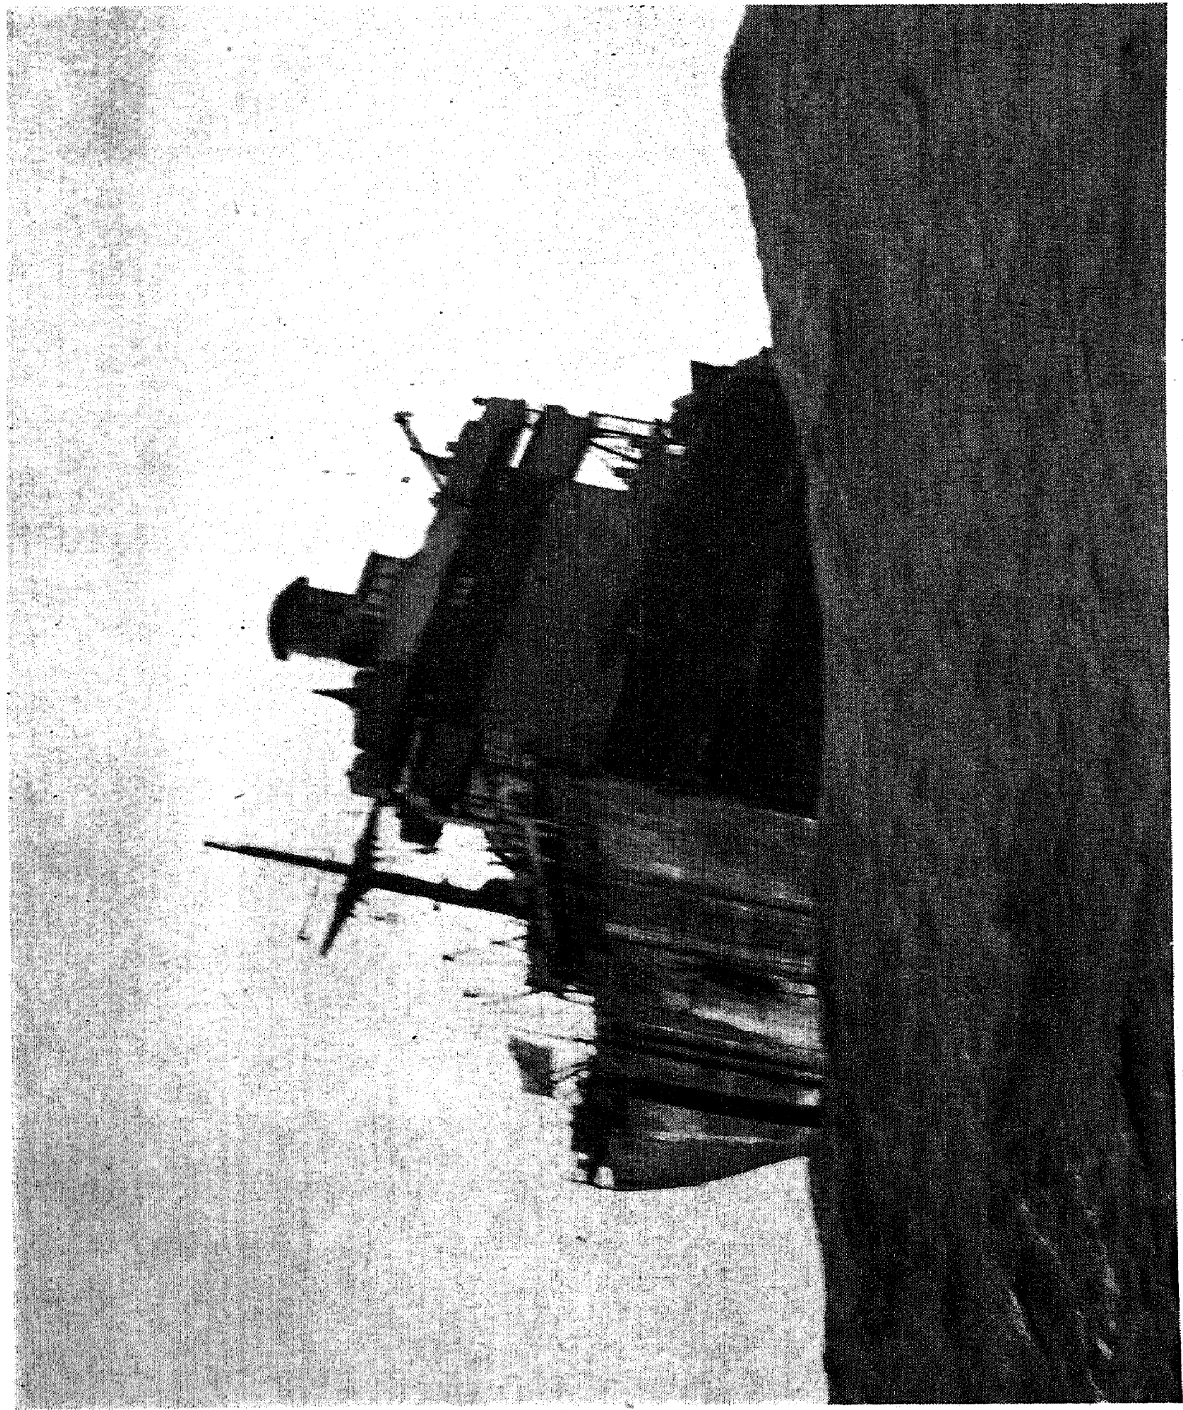
<b>The bow is believed to have sunk. The stern is aground on Big Koniuj1 Island.</b>	
SIGNED (Name and Title)	DISTRICT

FIGURE 4.—Stern portion of S. S. John P. Gaines.

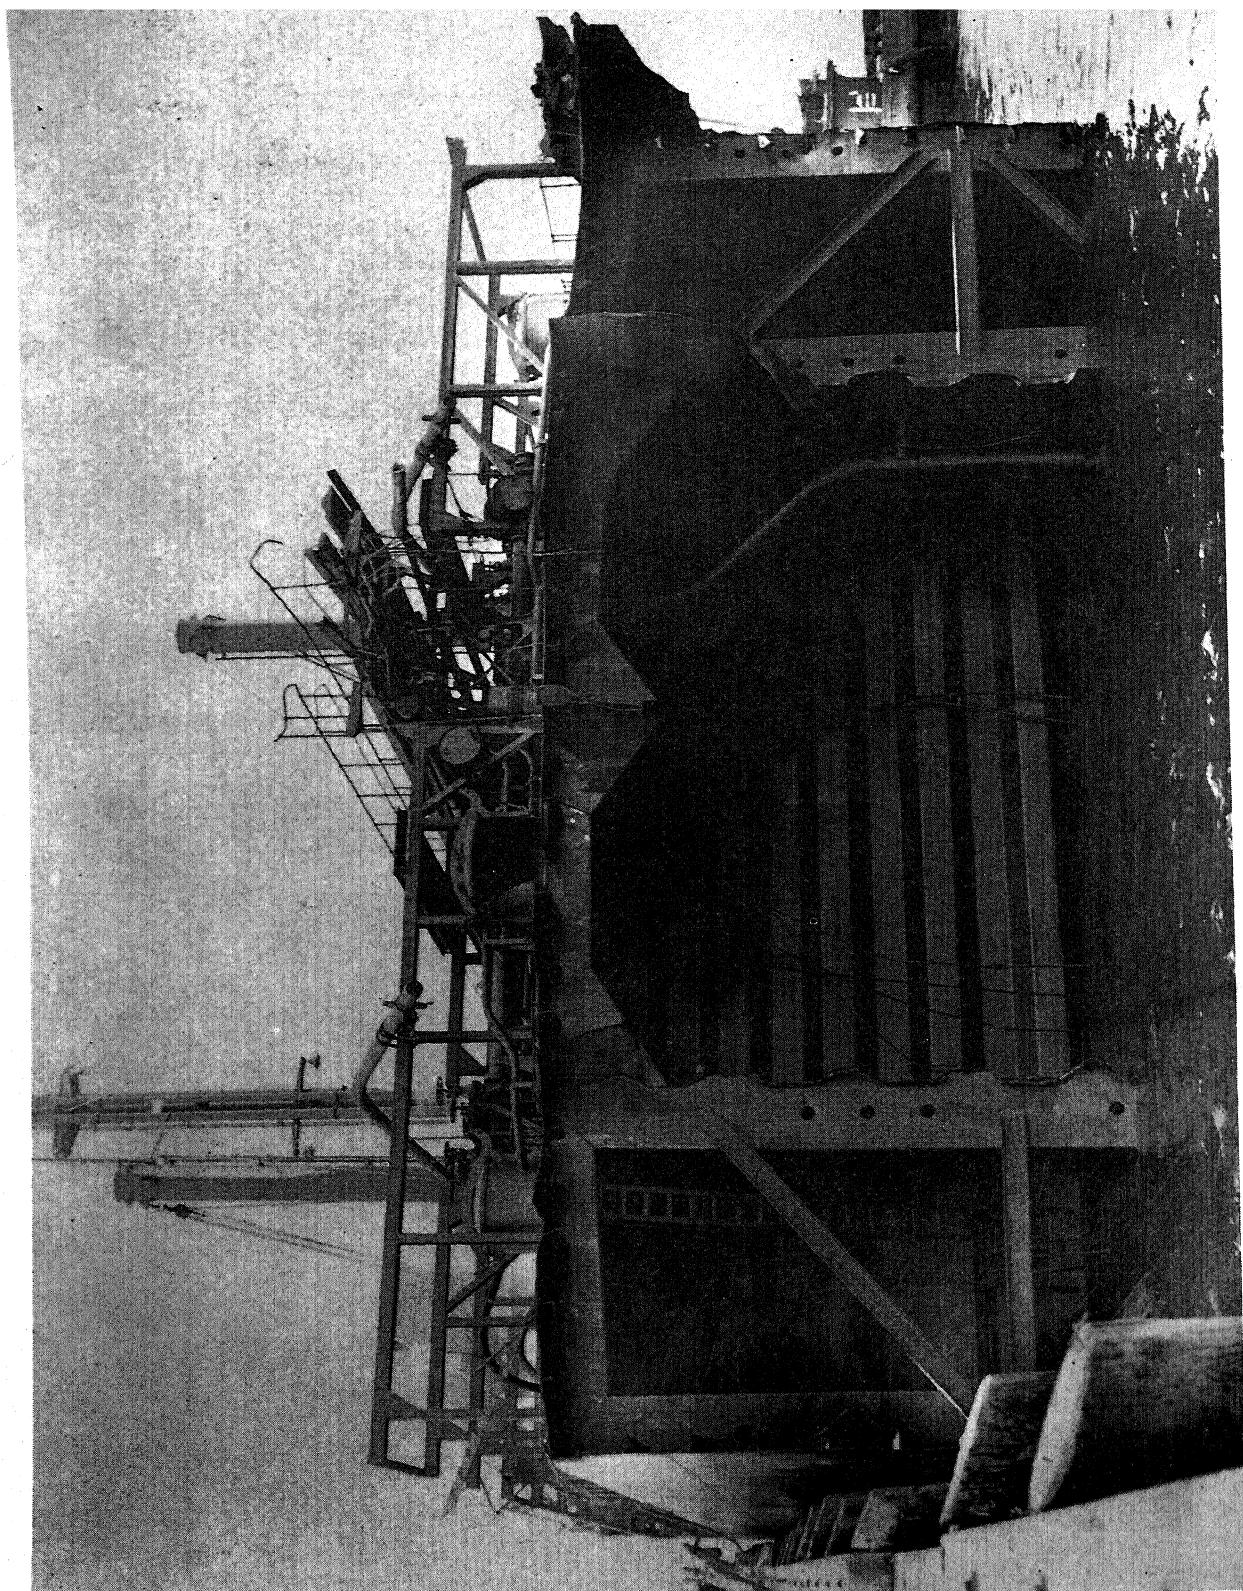
FIGURE 10.—Stern portion of S. S. Sacketts Harbor.

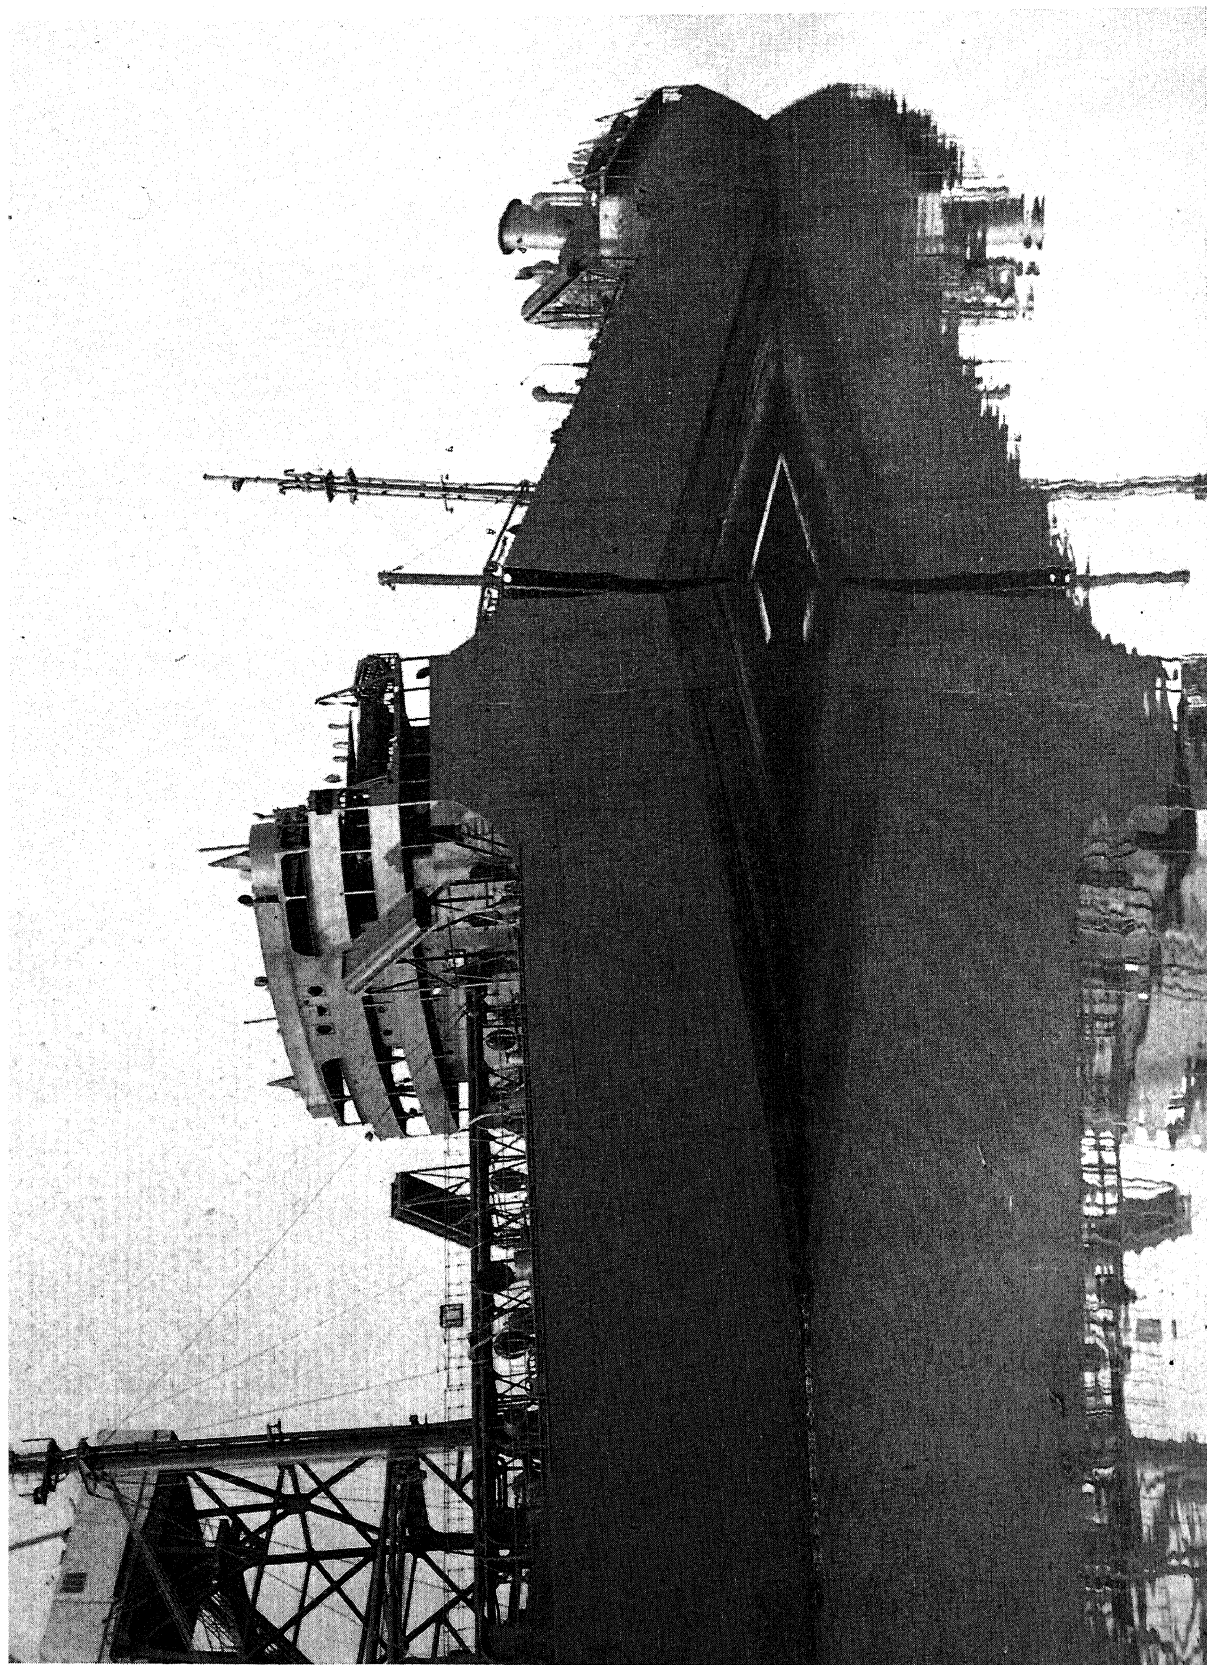
FIGURE 11.—View of S. S. *Schenecady* after splitting in two at her outfitting dock.

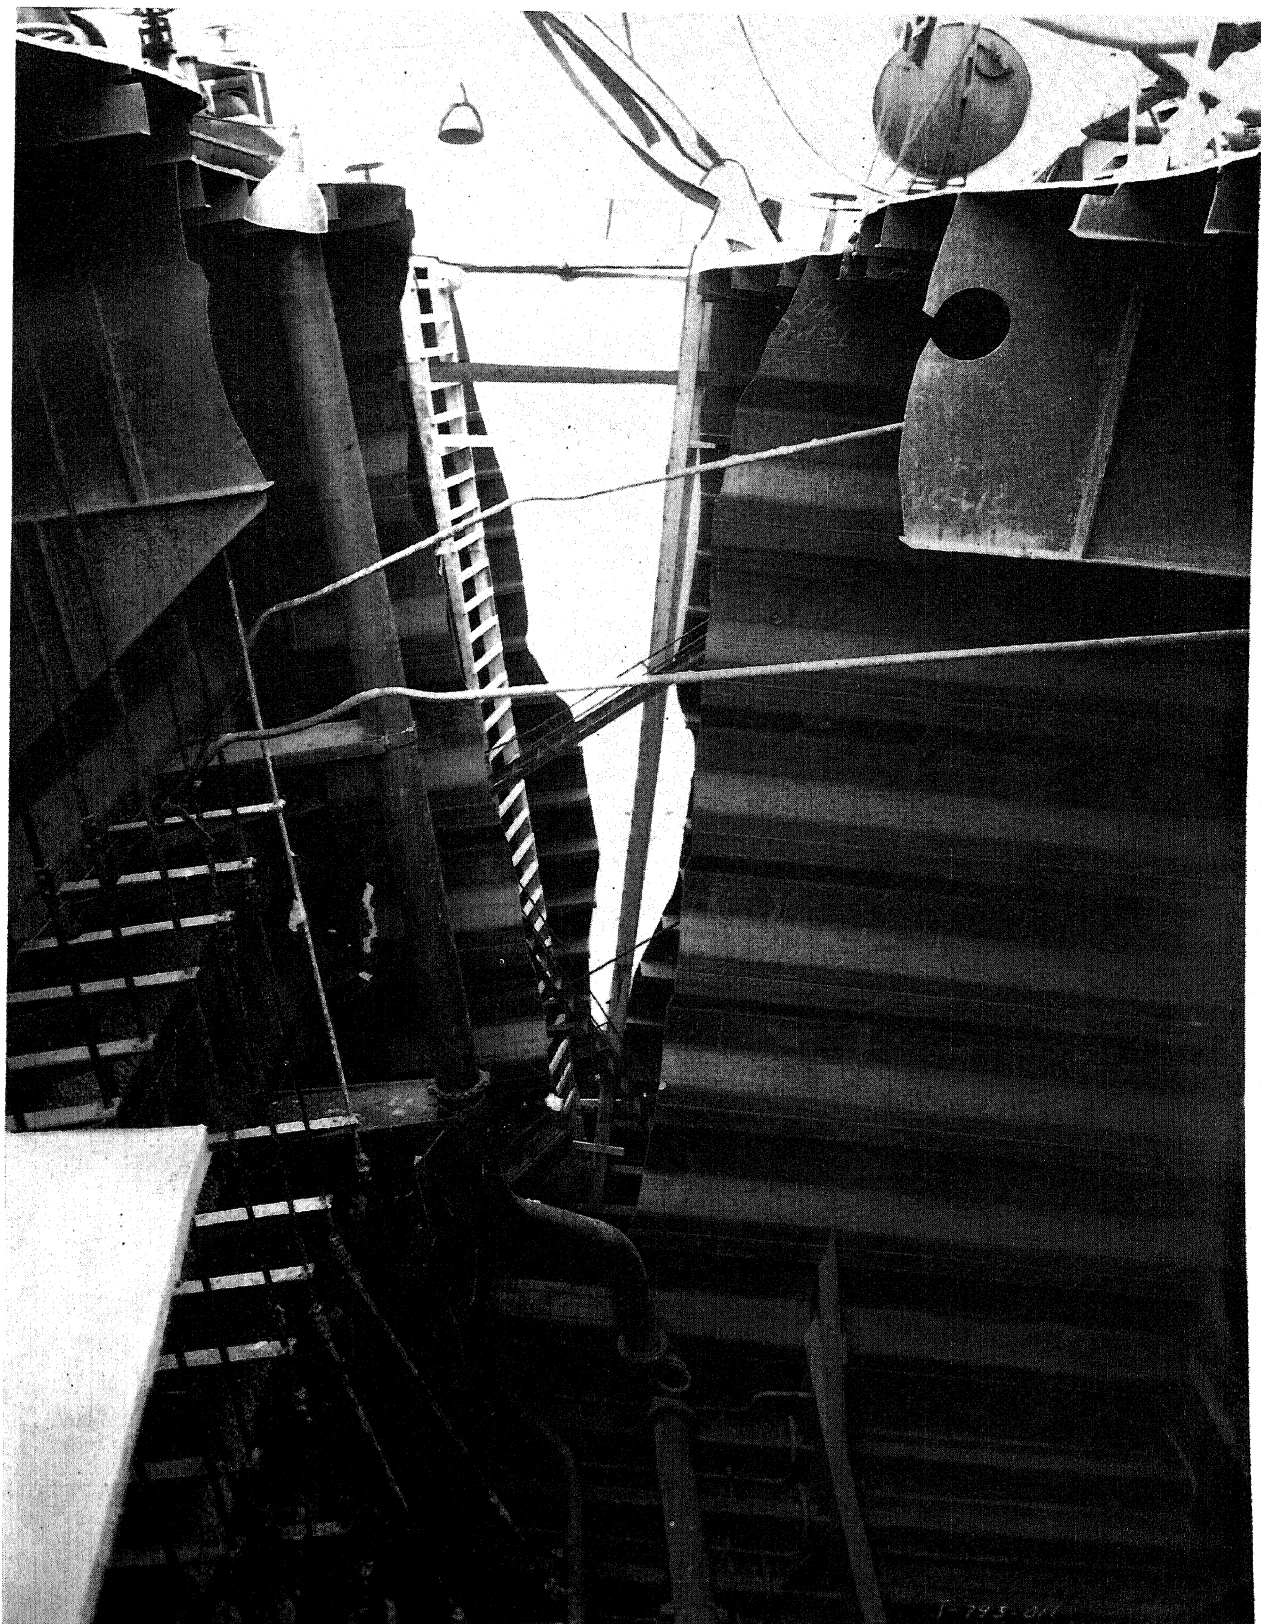
FIGURE 12.—*S. S. Schenectady*, view inside crack showing complete fracture of longitudinal bulkheads.

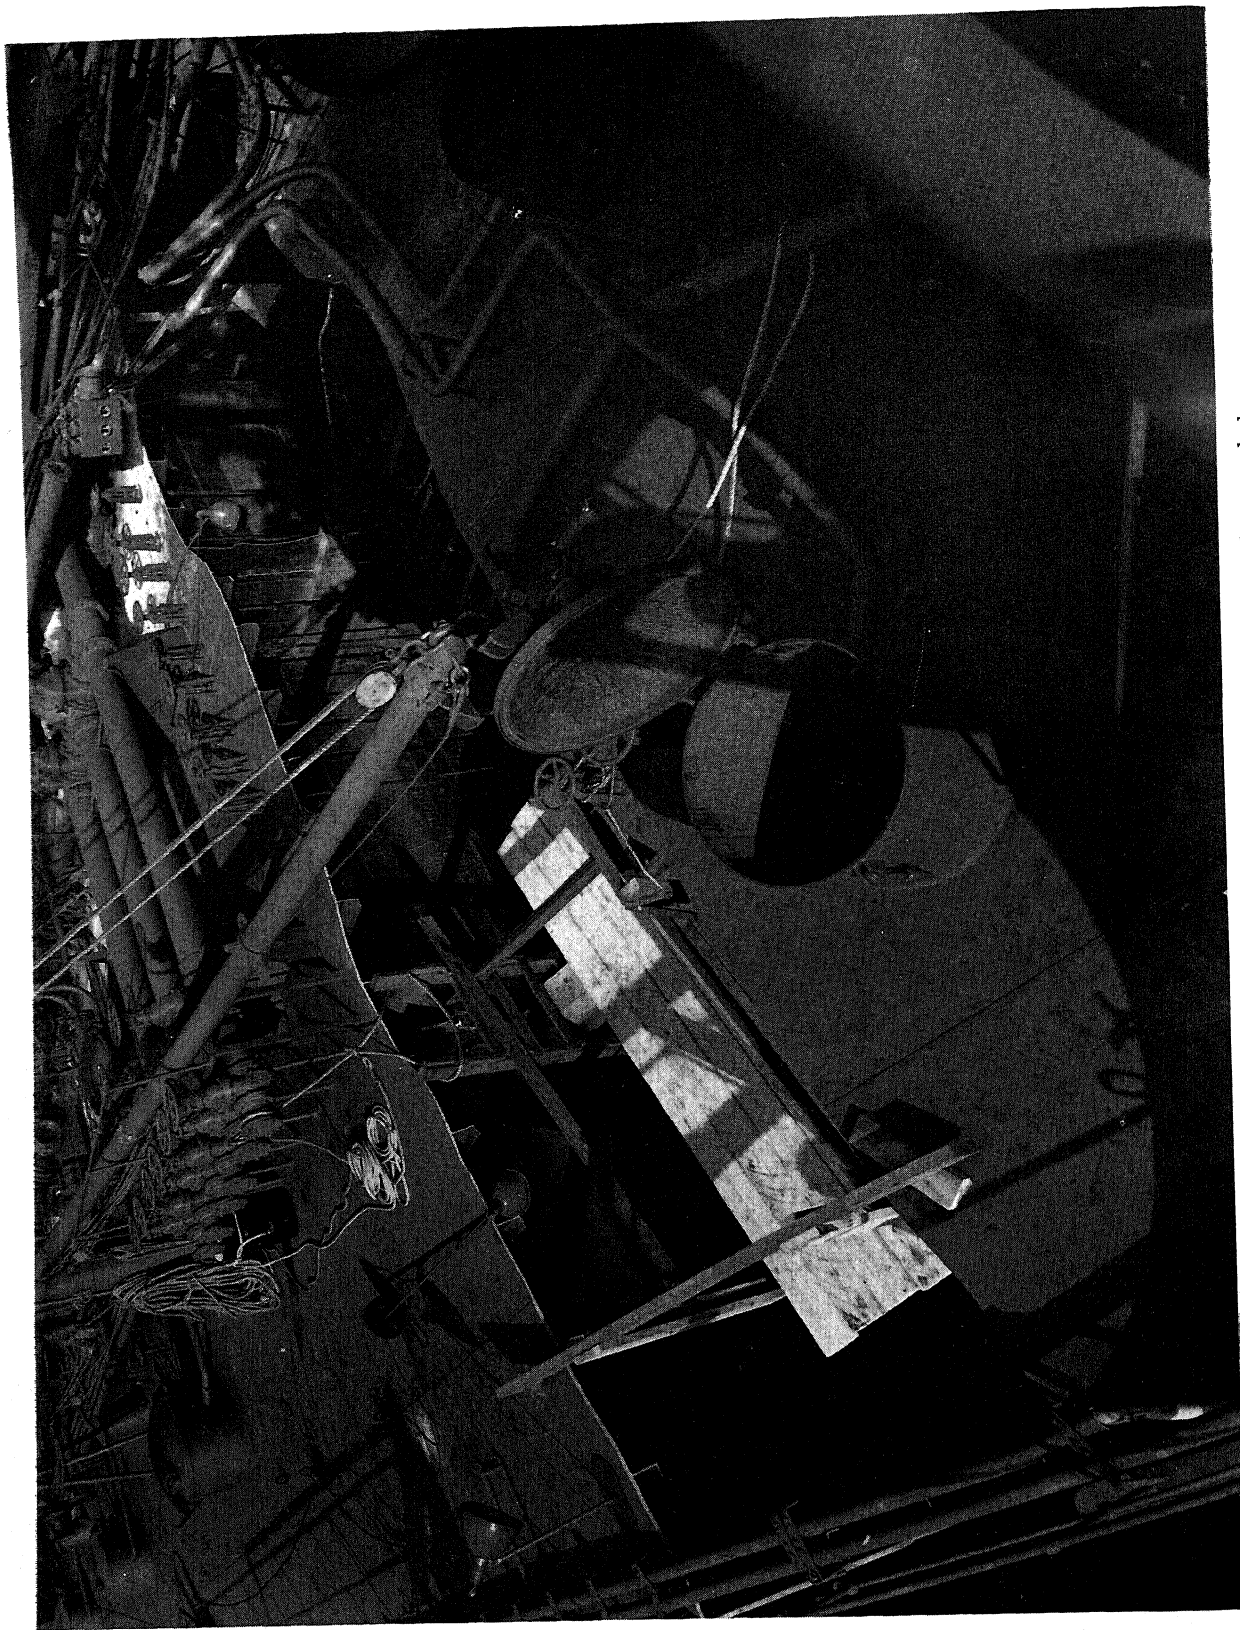
FIGURE 13.—S. S. *Schenectady*, view looking down at inside of crack across deck.

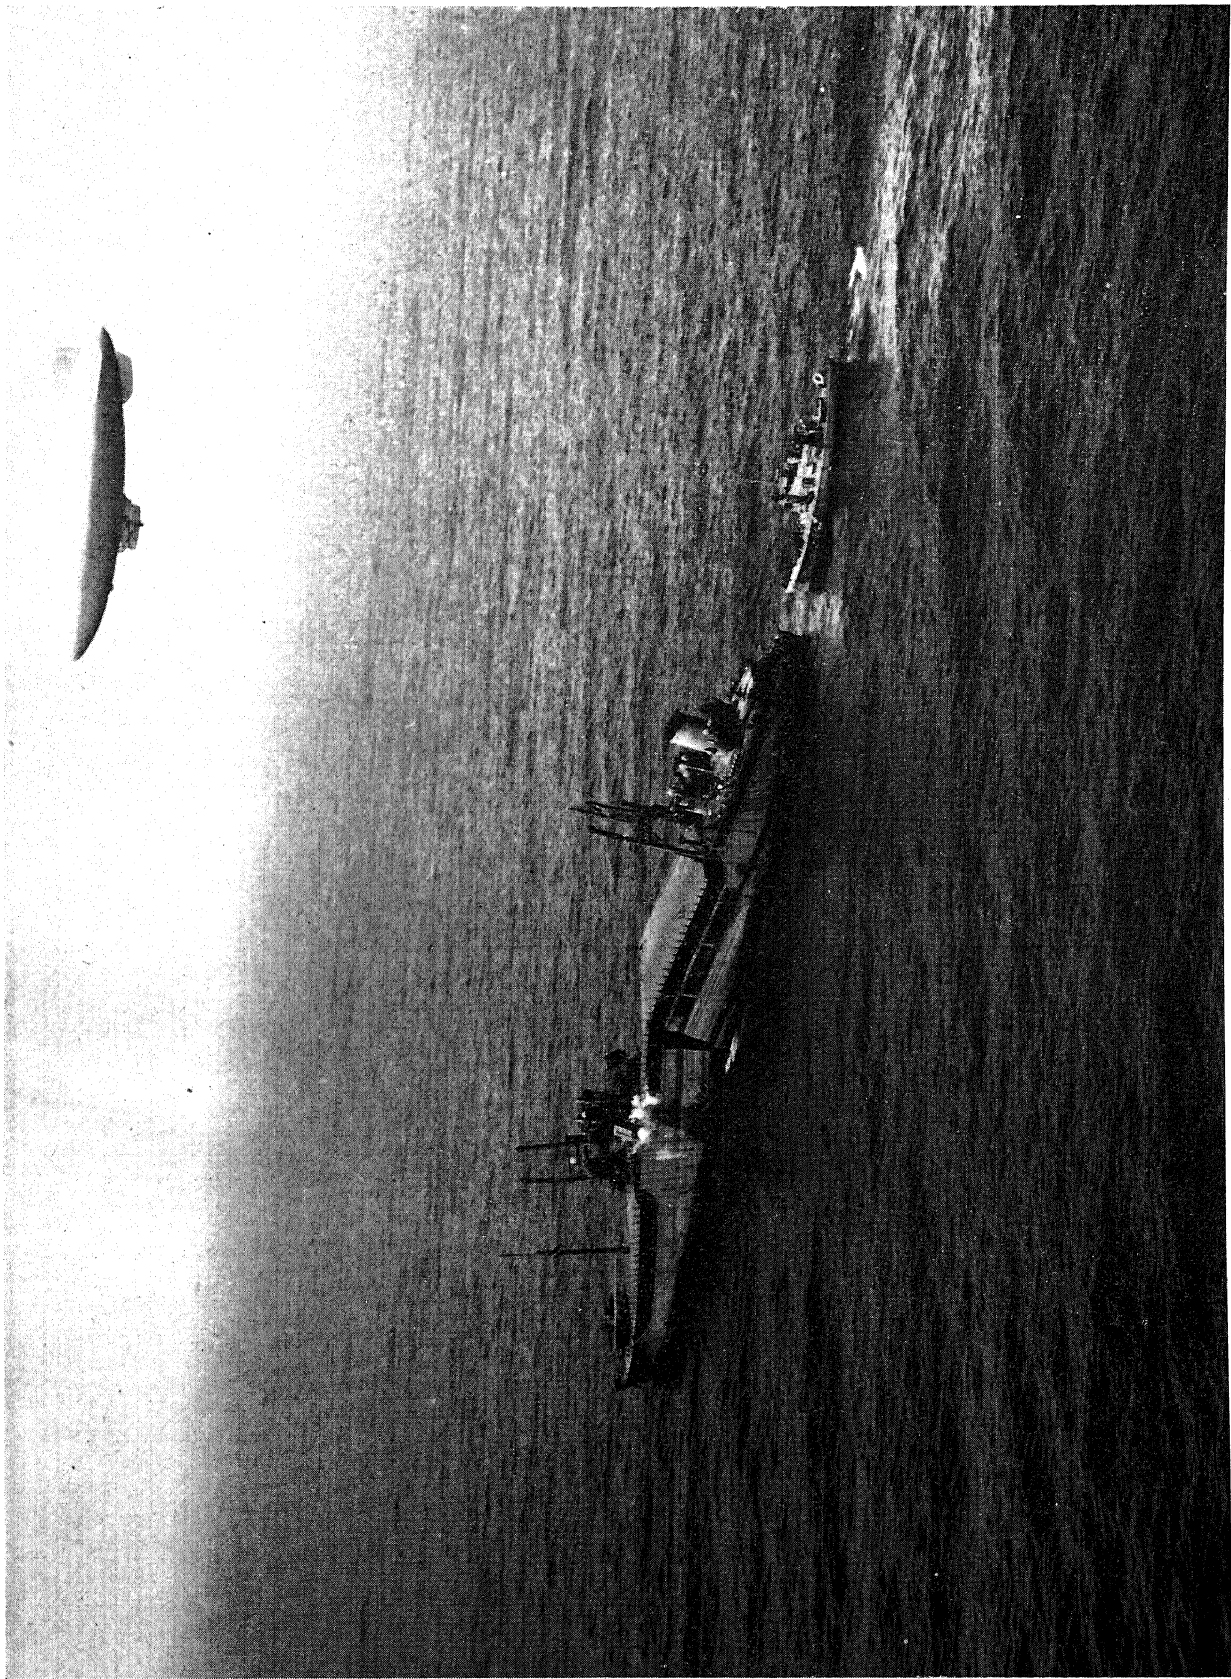
<p>Repaired on drydock at Todd Erie Basin and returned to service.</p>	
SIGNED (Name and title)	DISTRICT

FIGURE 16.—Aerial view of failure of S. S. *Esso Manhattan* taken from one of two blimps conveying vessel.

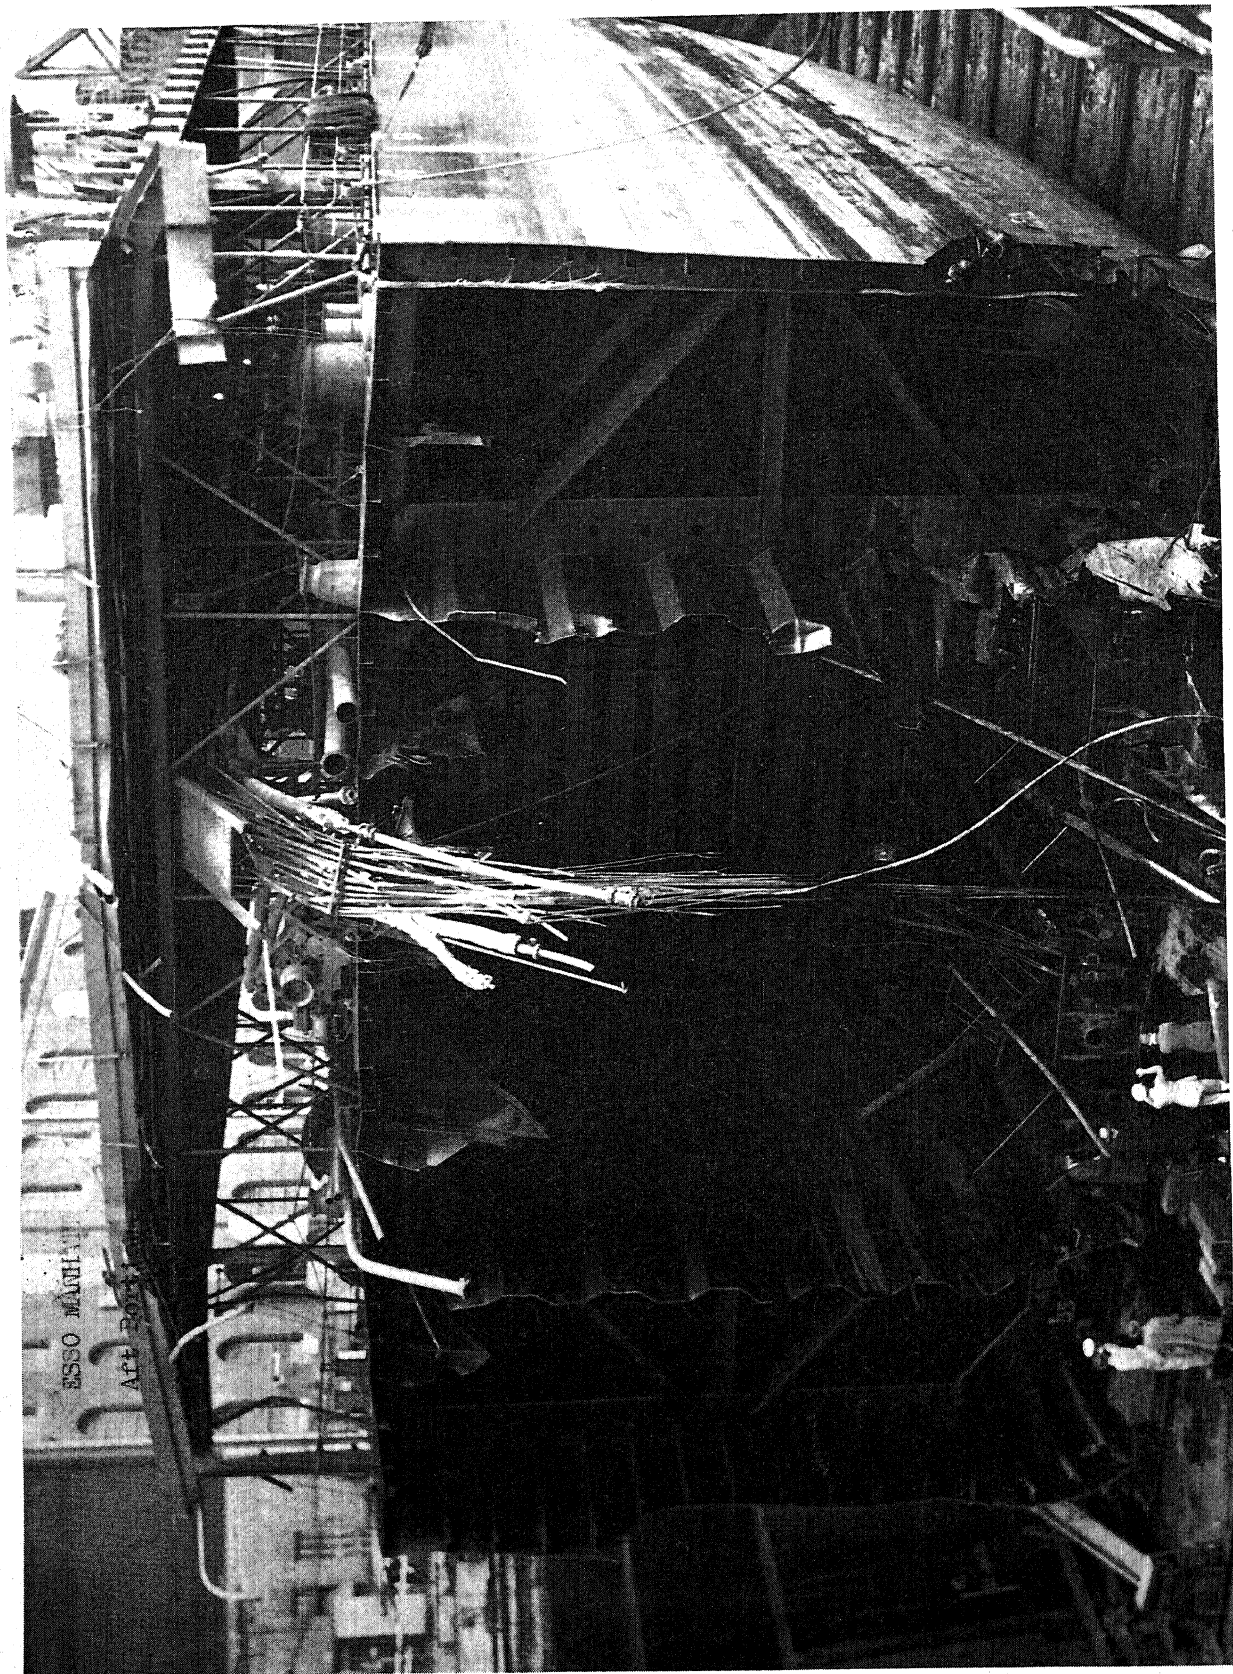
Figure 17.—Aft portion S. S. Esso Manhattan.

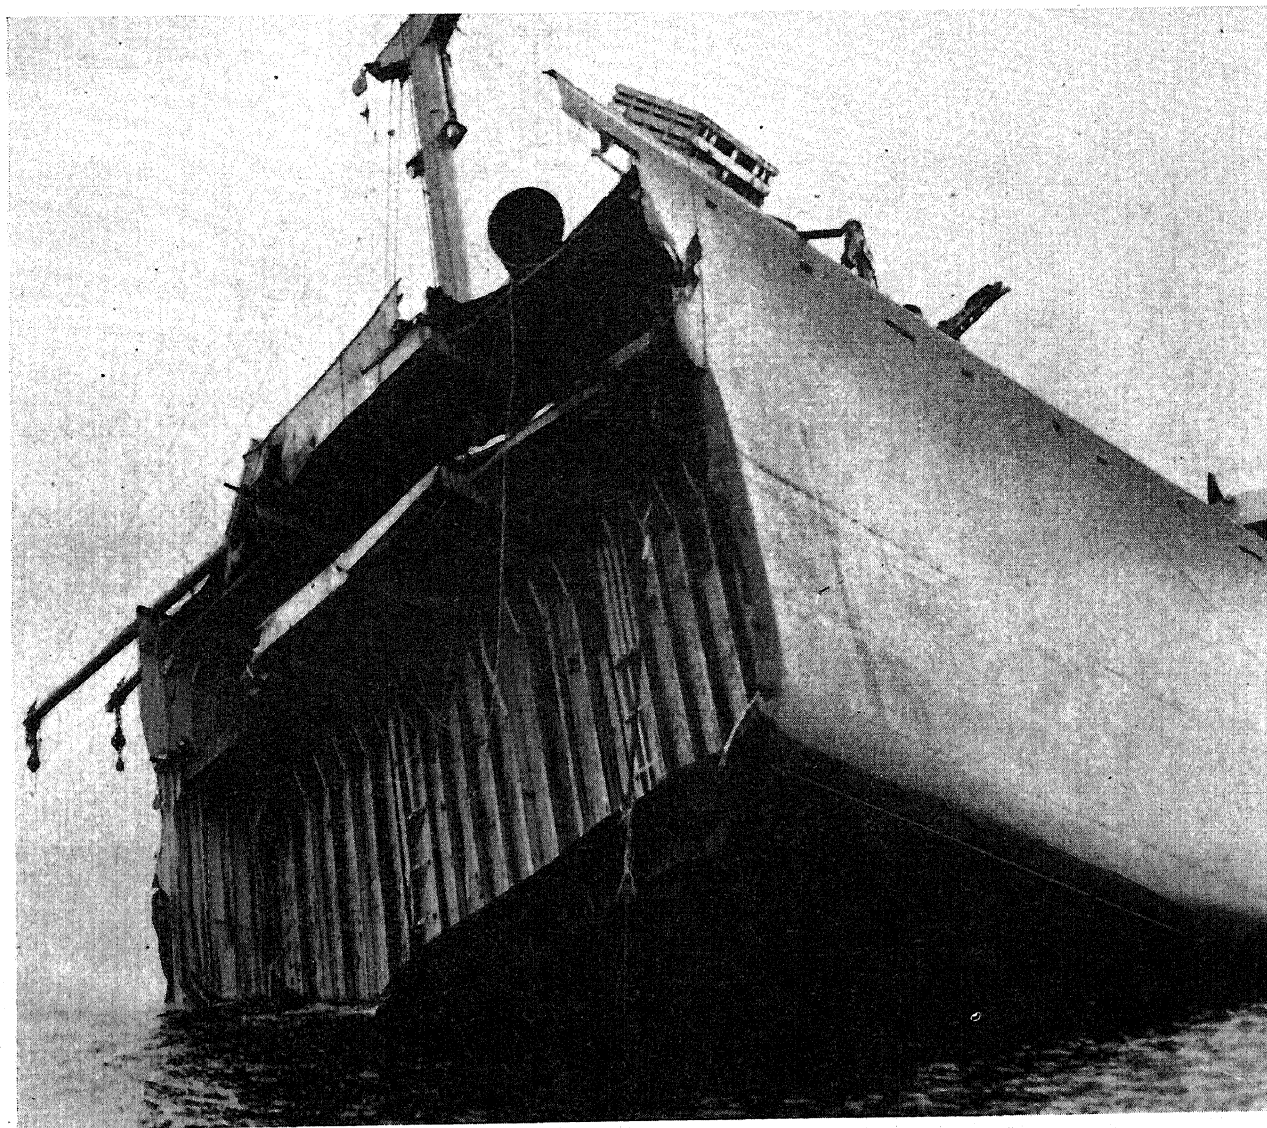
FIGURE 18.—Forward portion of *S. S. Valeri Chkalov*.

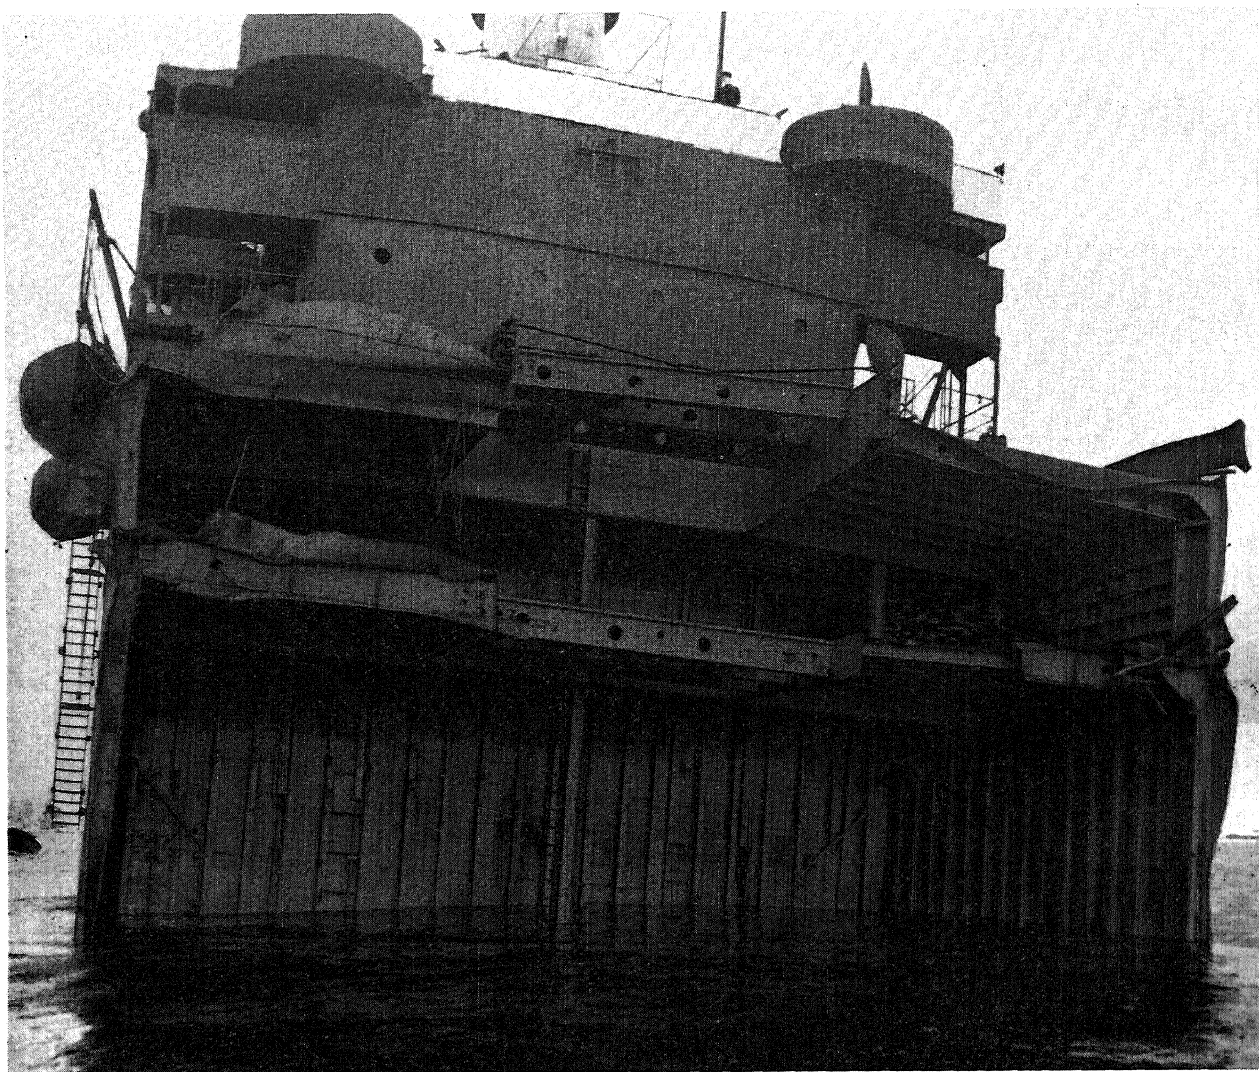
FIGURE 19.—Stern portion of *S. S. Valeri Chkalov*.

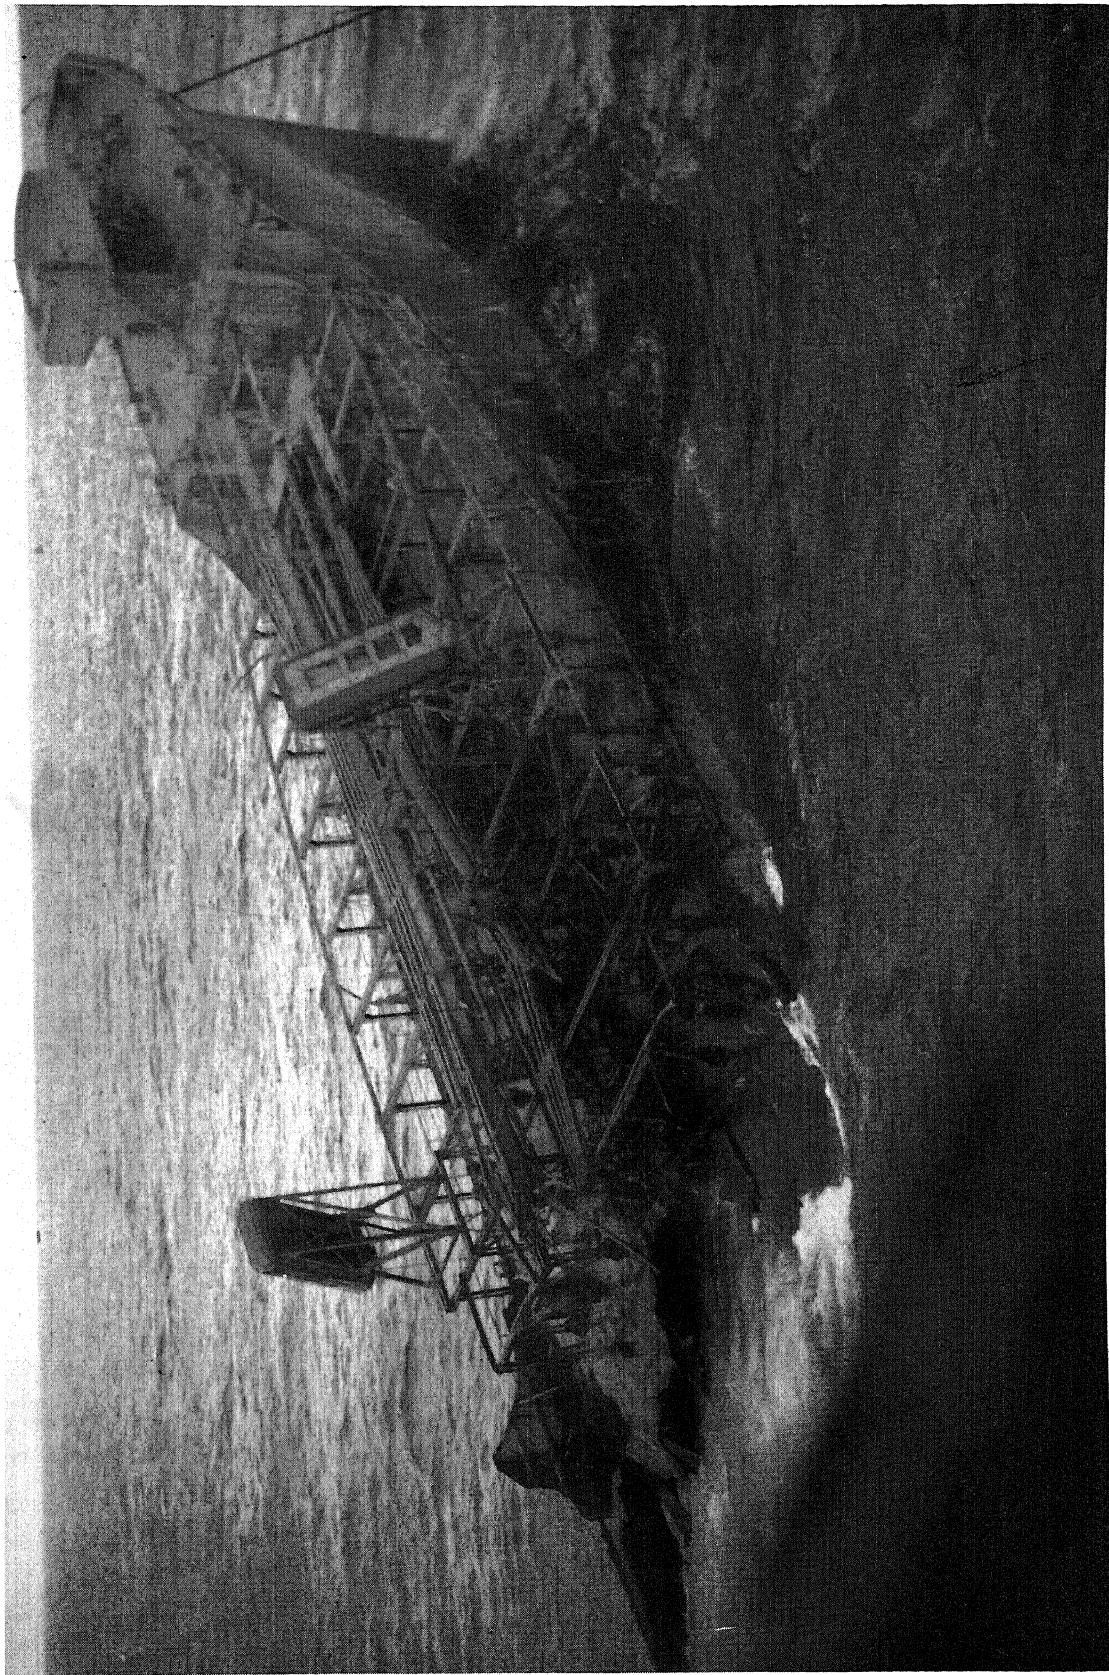
FIGURE 22.—Forward portion of *S. S. Donbass III*.

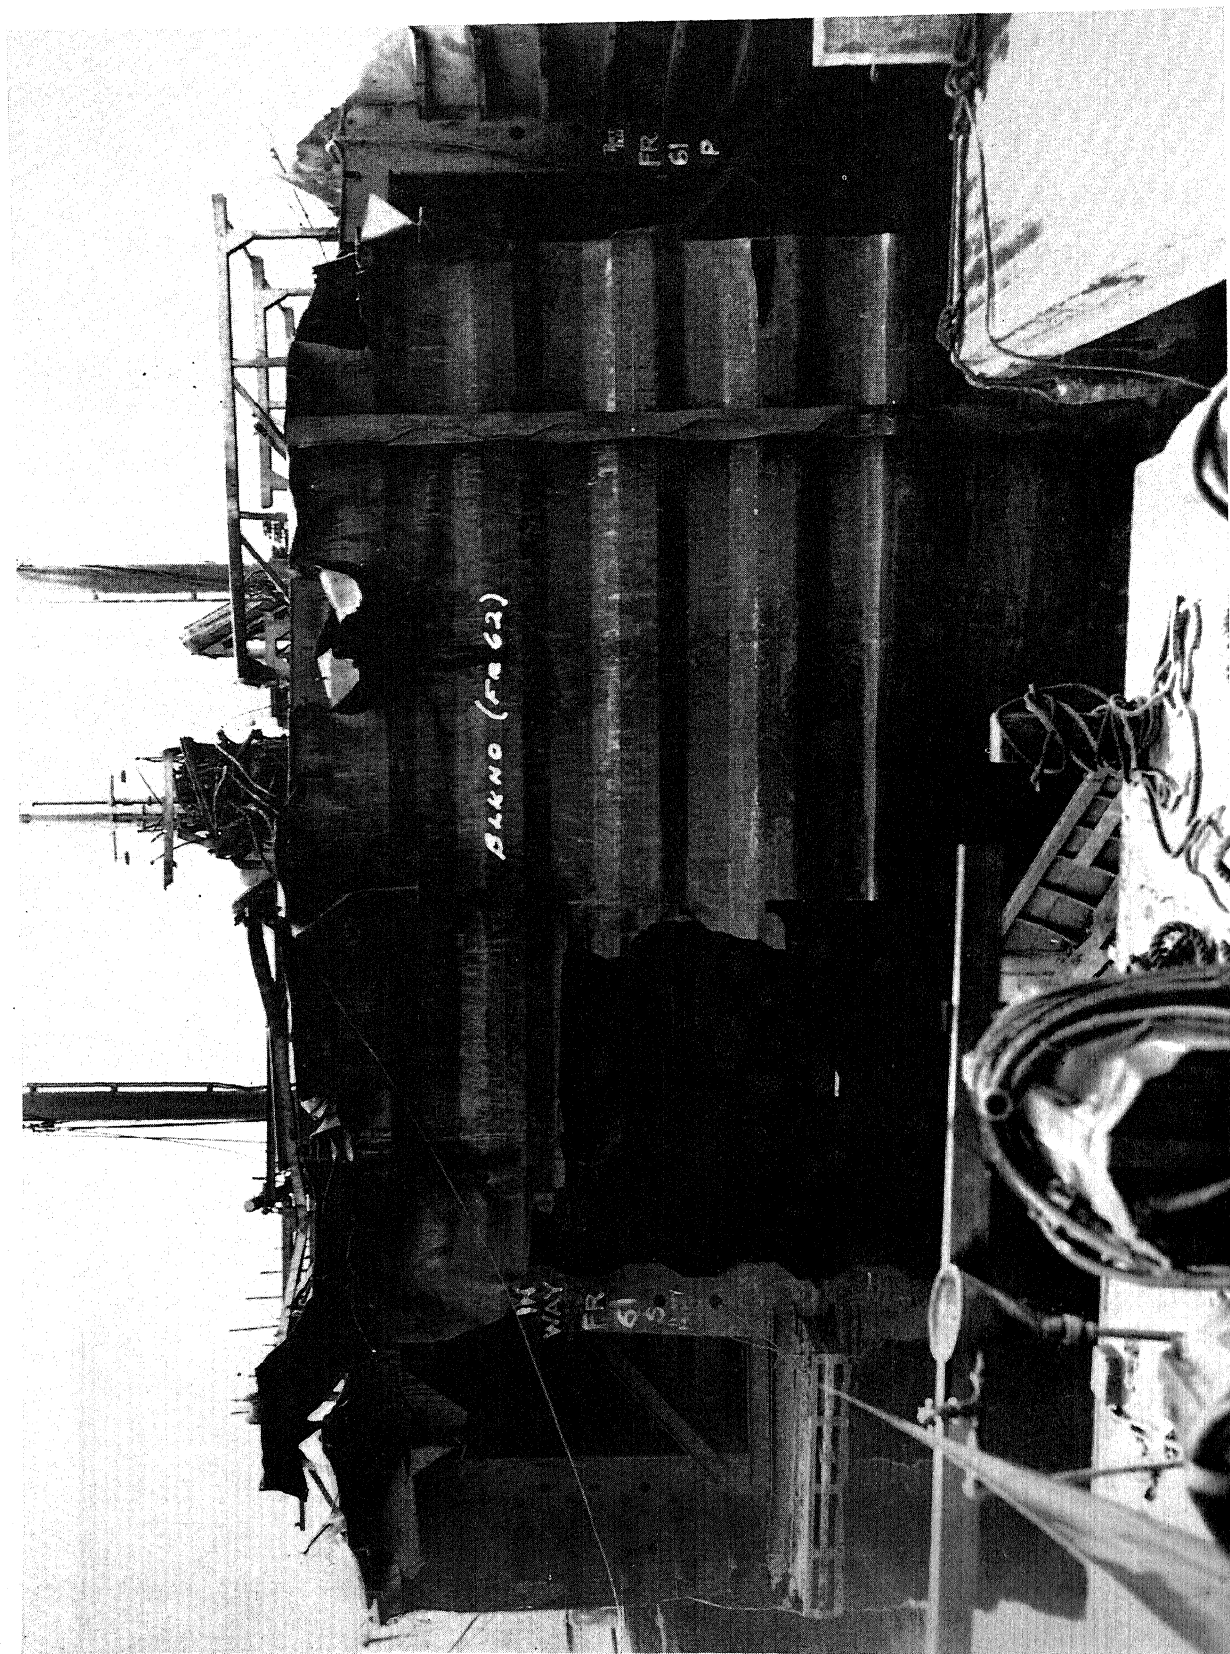
FIGURE 23.—Stern portion of S. S. Donbass III.

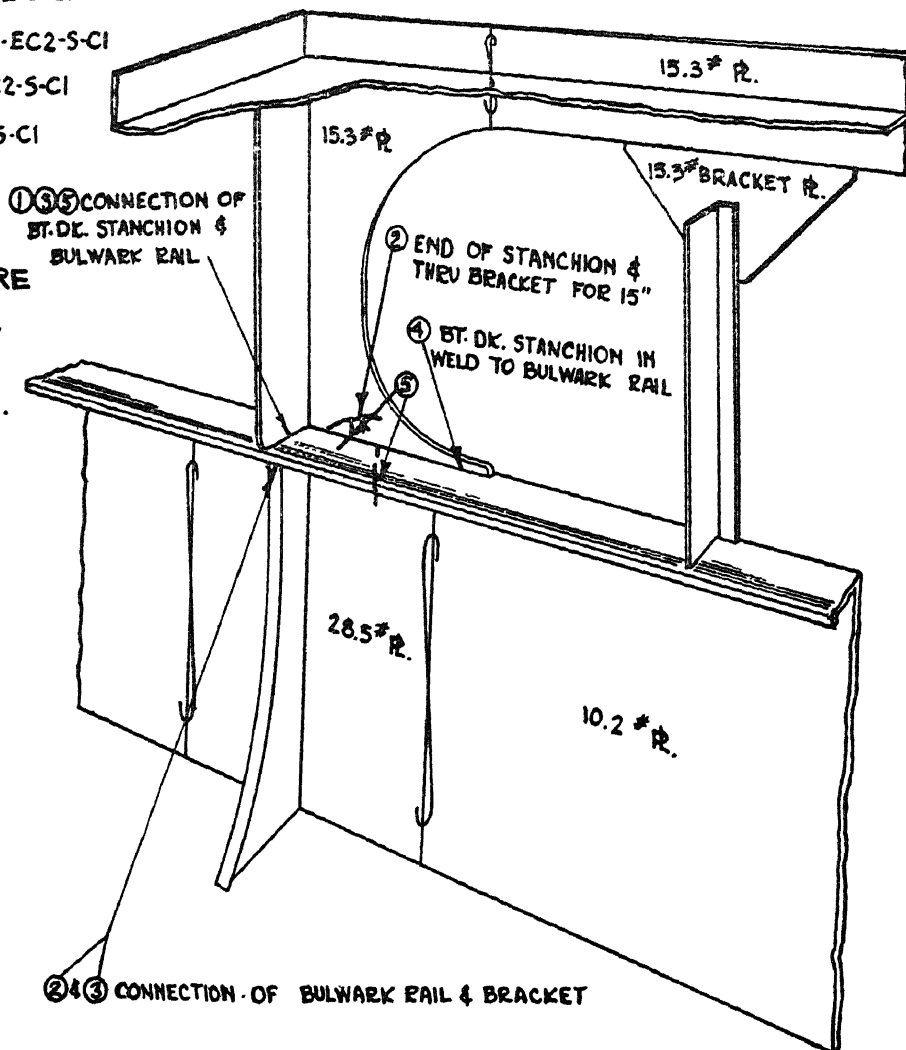
Figure 34.

UP TO 1, AUG, 1945  
260 FRACTURES WERE  
REPORTED TO HAVE  
OCCURRED AT THE  
BOAT DK. STANCHION.
